**Glen Echo Lake, Charlton, Massachusetts  
2016 Year-End Report**

*Report Date:* November 18, 2016

In accordance with the aquatic plant management contract between SÖLitude Lake Management and The Glen Echo Improvement Association (GEIA) for treatment of variable milfoil (*Myriophyllum heterophyllum*) and fanwort (*Cabomba caroliniana*) in 2016, the following document serves to provide this year's treatment and survey results and the management recommendations for next season.

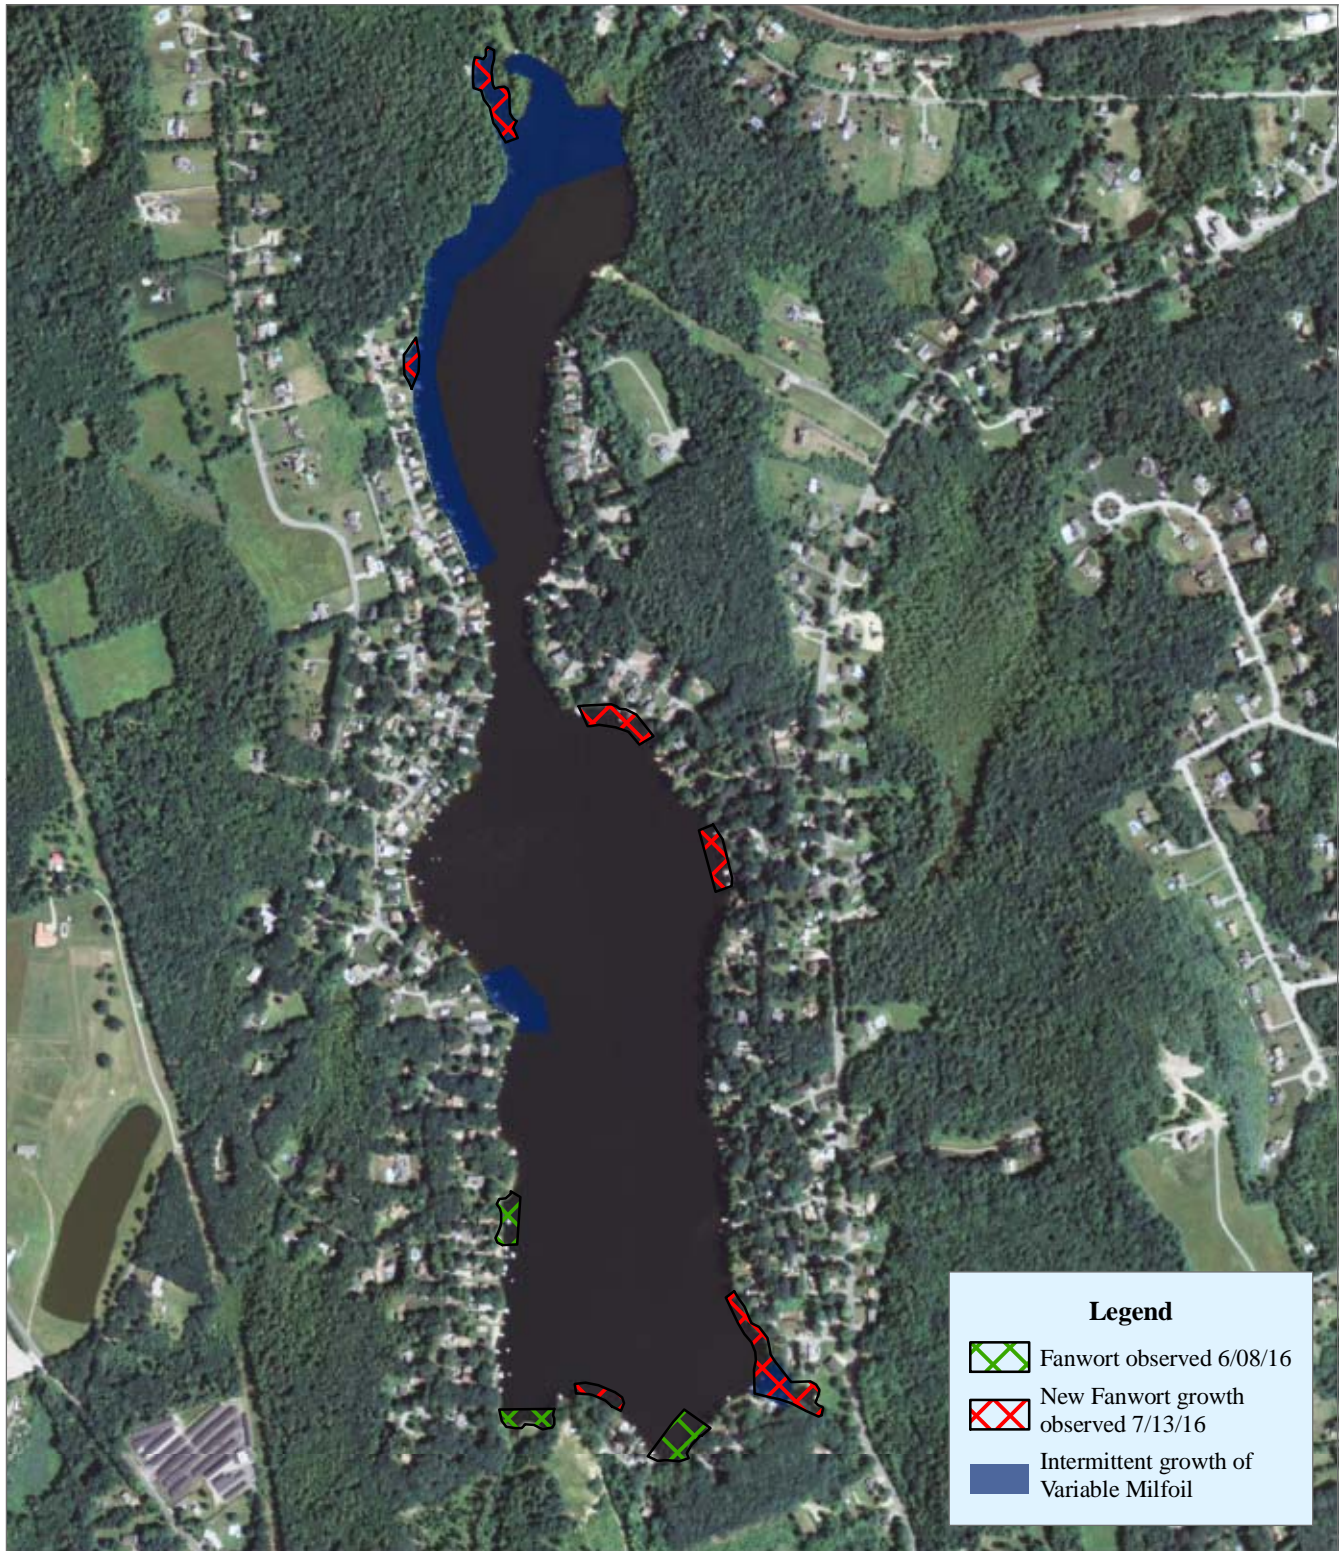
Figure 1: Pre-Treatment Distribution of Invasive Aquatic Vegetation Species

On May 9<sup>th</sup> and June 8<sup>th</sup>, a SÖLitude Biologist conducted vegetation surveys to assess the relative abundance and distribution of aquatic vegetation (specifically fanwort and variable milfoil) throughout Glen Echo Lake and to finalize management strategies for the 2016 season. During the May survey, the entire waterbody was toured and plant growth observations were noted. At the time of the May survey, fanwort growth was not yet present, and variable milfoil was just beginning to break through the sediment in the northwest finger cove. Therefore, a second survey was conducted on June 8<sup>th</sup>; at this time both fanwort and milfoil had appeared in multiple locations. These locations were recorded via Garmin GPS points and along with data collected during the 2015 fall survey, were used to designate treatment areas. A map depicting the distribution of aquatic vegetation is attached.

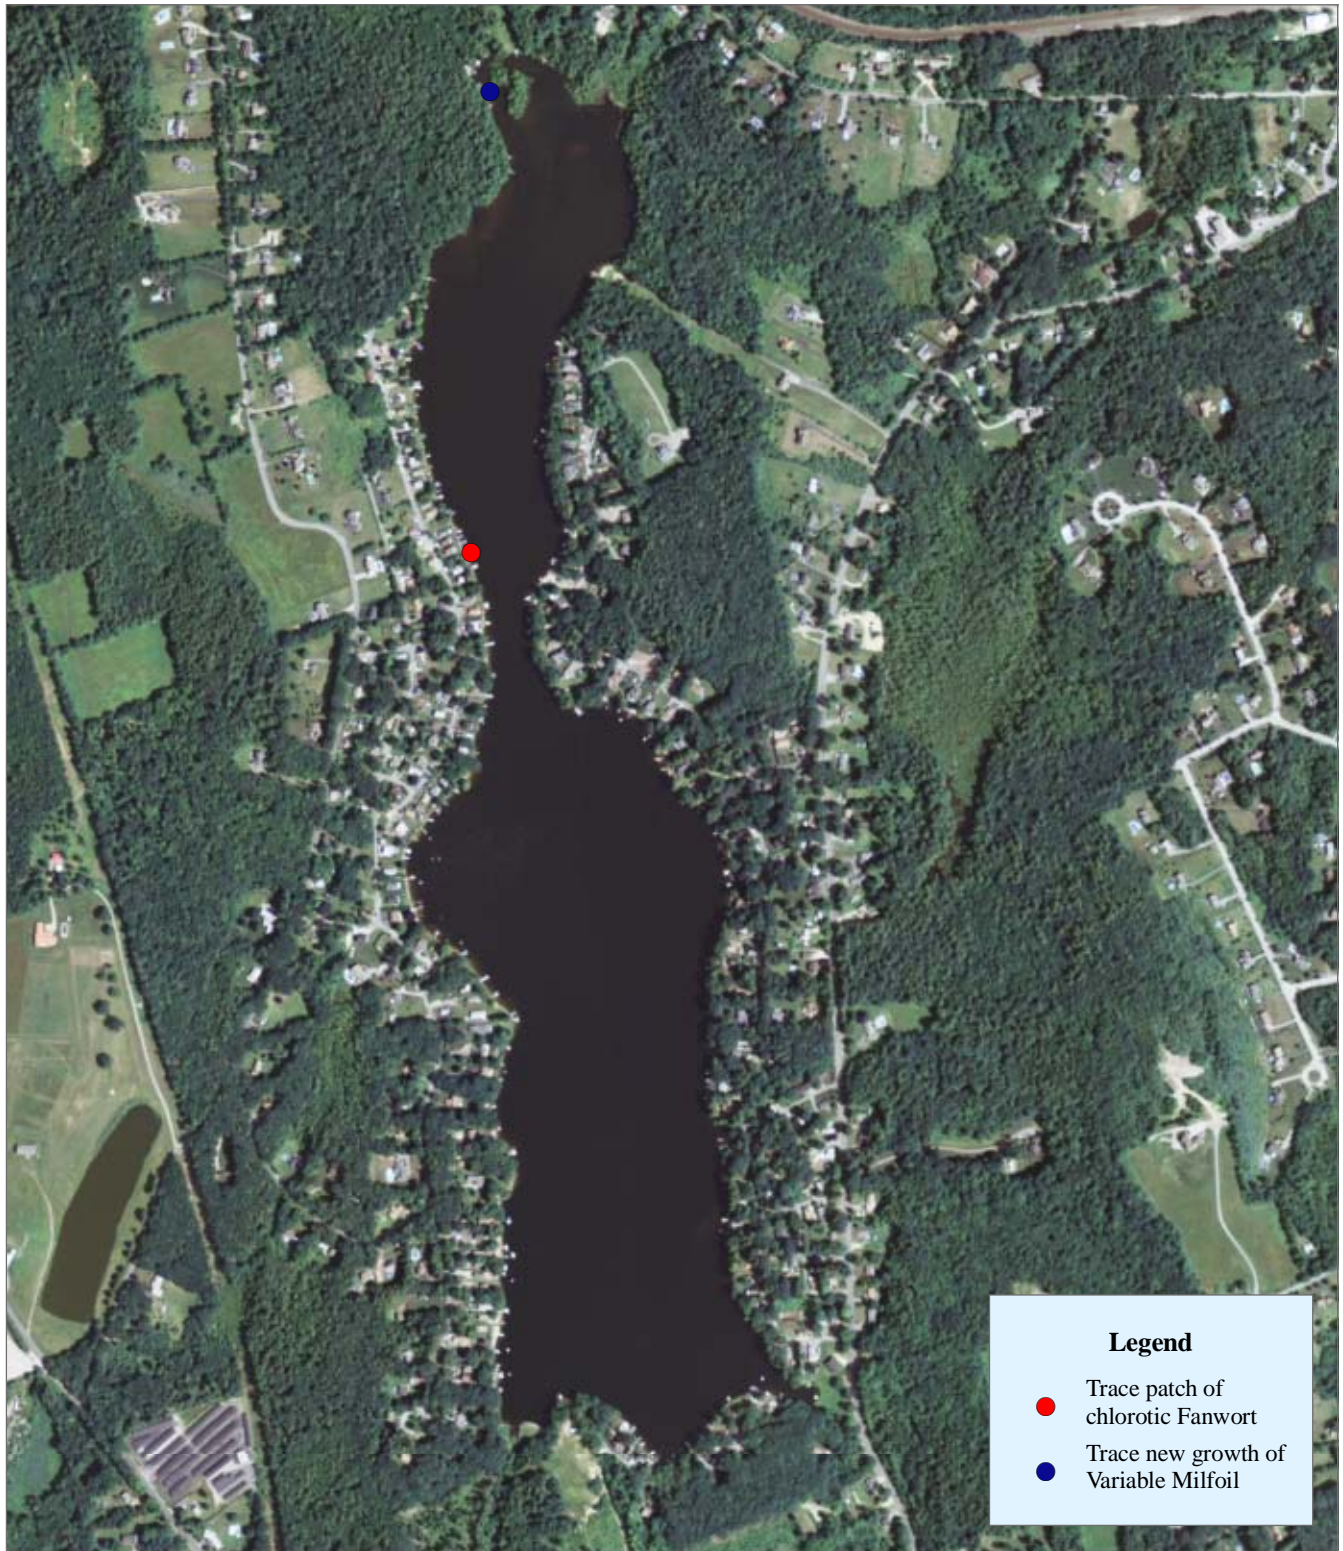
Figure 2: Post-Treatment Distribution of Invasive Aquatic Vegetation Species

On September 28<sup>th</sup> two SÖLitude biologists performed a post-treatment inspection of Glen Echo Lake to evaluate the effectiveness of the herbicide applications. Results from the treatments were positive as the abundance and distribution of both fanwort and variable milfoil were reduced significantly. Ultimately, neither of these species were observed more than once during the post-treatment inspection. The only observation of variable milfoil was noted towards the back of the northwest finger cove; there was no more than a handful of new, low-biomass growth, which is to be expected when using contact herbicides as opposed to systemic herbicides. The only observation of fanwort was on the western side of the northern basin, shortly after passing through the narrow section. This patch of Fanwort appeared chlorotic and not viable.

A map depicting the post-treatment aquatic vegetation distribution is attached.

Based on the success of the Sonar and Reward treatments performed in 2016, we recommend continuing with this approach for the 2017 season. Given the management success in 2016, we anticipate less growth in 2017 however pre-management surveys will continue to give us the most accurate area and acreage. In the past couple of years, fanwort growth has been sporadic and areas of growth have emerged at different times so we will continue to conduct surveys on the day of treatment
