RE: Glen Echo Lake, Charlton, Massachusetts
2014 Herbicide Management Summary Report

Final Report for 2014 Aquatic Plant Management

Glen Echo Lake

Charlton, Massachusetts

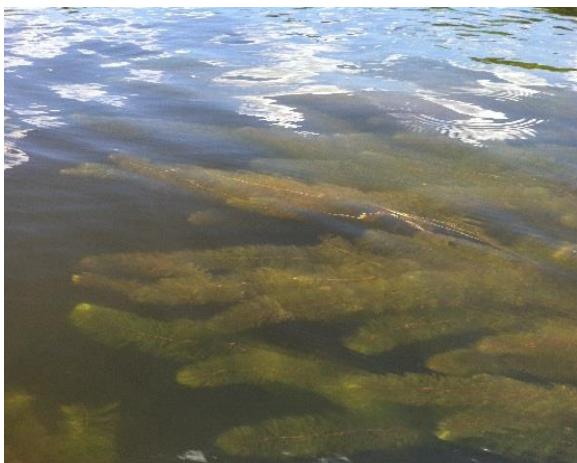
Image 1: Moderate to dense V. Milfoil

A pre-management survey was conducted on July 1, 2014 by Lycott biologists, to determine the distribution and relative abundance of the target species throughout Glen Echo Lake. Results of this survey indicated that moderate to dense invasive, non-indigenous *Myriophyllum heterophyllum* (Variable Milfoil, V. Milfoil) typified several large areas (totaling approximately 50 acres) at Glen Echo Lake. As historically seen, much of the V. Milfoil infestation was observed in the northern basin; however, growth of V. Milfoil can now be seen along the eastern and western shorelines along Glen Echo Shore Road, Sunset Drive, Lakeview Drive, and in the south basin along Steven Parks Road (**Appendix: Figure 1-A**). Representative images of the V. Milfoil observed during the pre-management survey are shown below:

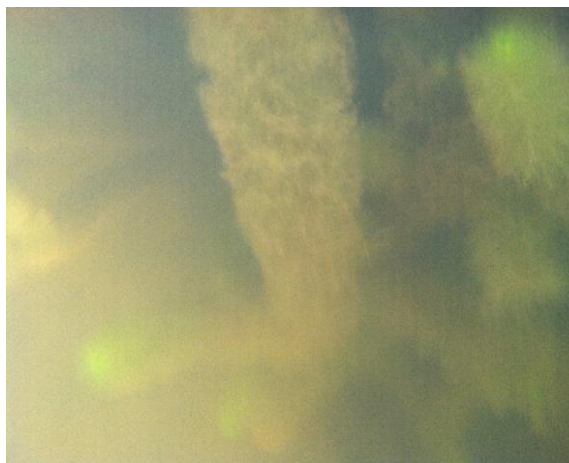
Image 2: Subsurface look at V. Milfoil

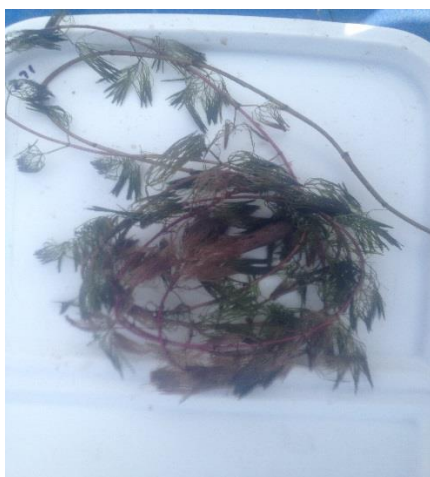
The following pictures were taken on July 30, 2014 by a Lycott applicator, notice the chlorosis; **Image 3** shows pink chlorosis on Fanwort out of the water, while **Image 4** shows some pink chlorosis on submersed Fanwort. Treatment tracks for each herbicide application can be found in the **Appendix: Figure 2**.

Image 3: Chlorotic Fanwort retrieved via rake toss

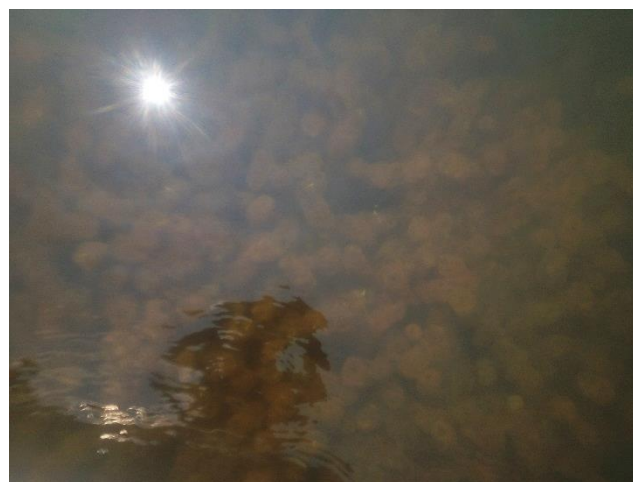
Image 4: Chlorotic submersed Fanwort

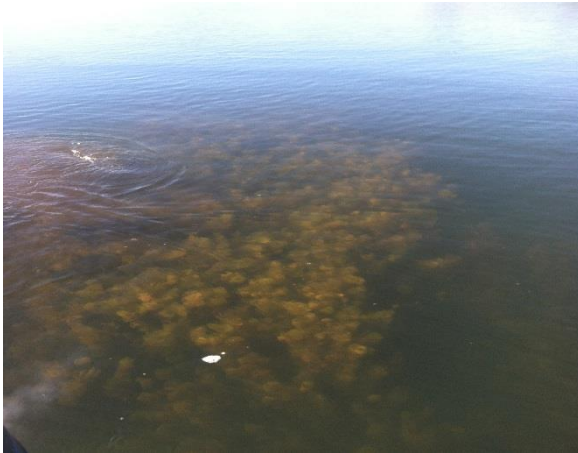
A post-management survey was conducted on October 6, 2014 by Lycott biologists. Results of this survey indicated that Fanwort expanded beyond its pre-treatment survey, mid-season survey and herbicide treatment extent (approximately 5 acres total), by approximately seven (7) acres (**Appendix: Figure 3-A**) (**Images 5 & 6**); this may have been due to the start of application beginning mid-summer. The extensive growth of nearly 50 acres of V. Milfoil may have suppressed the Fanwort plants as they had not been observed during the July survey (other than the two locations in the southern basin). Once the treatment of the V. Milfoil was conducted and took effect, the previously suppressed Fanwort was able to proliferate throughout the water

body. Fanwort has a very fragile stem structure, this benefits the species as it aids in reproduction. Fanwort will grow seeds but its primary means of reproduction is via fragmentation, and given that Glen Echo Lake is a highly recreational water body, it is likely that the Fanwort spread to other parts of the water body by fragmentation from recreational activity as well as fragmentation by the plant itself.

Image 5: Dense Fanwort located in the northern basin

Based on pre- and post-management surveys, Lycott recommends the use of systemic herbicides for long term control of both V. Milfoil and Fanwort in Glen Echo Lake. The products recommended are Sonar® One for Fanwort, and Renovate® OTF for V. Milfoil. Systemic herbicides offer longer lasting control of target species; they reduce/eliminate both recruitment (i.e., new plants added to the population in subsequent years) as well as the standing crop by attack the root system of the plant killing it from the root rather than burning it back at the leaves. Large areas of growth, when treated with systemic herbicides, are often eradicated or reduced to small areas of growth which are cheaper and easier to maintain in future years. If the GEIA chooses to continue contact herbicide treatments utilizing Reward® for V. Milfoil, Lycott suggests two herbicide treatments be conducted, one in late spring/early summer and one later in the summer for any regrowth that may occur.

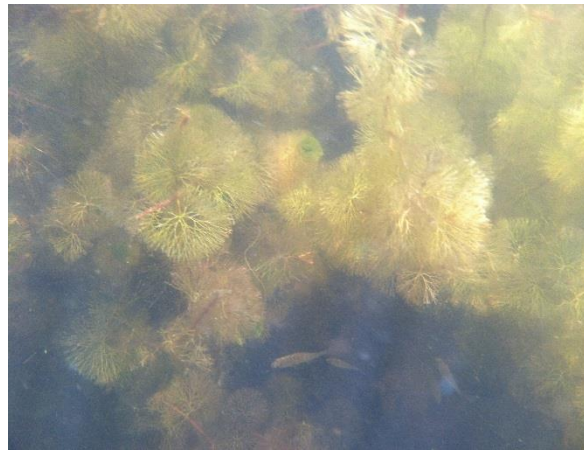
Image 6: Subsurface look at Fanwort in the northern basin

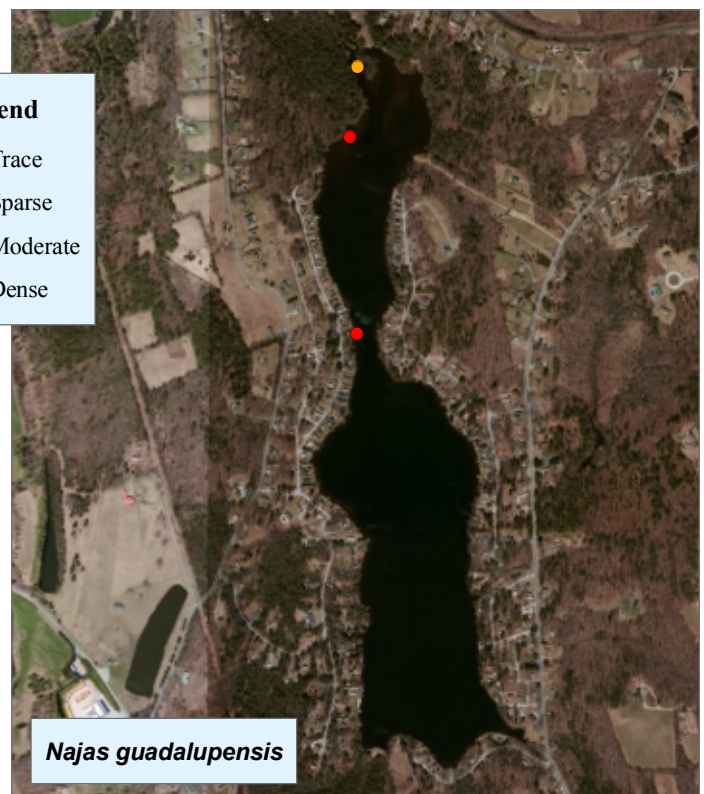
Figure 1-B: July 2014 Distribution of Remaining Aquatic Vegetation Species

The aquatic plant community observed was comprised primarily of the invasive, non-native species, Variable Milfoil; this species spanned approximately fifty (50) acres. Nine (9) native species were also noted during this survey and are listed in the table below. These species were limited to the littoral zone area and observed intermittently at trace to dense abundances. A map depicting the extent and relative abundance of aquatic vegetation observed during the 2014 pre-management survey is attached to this report (**Appendix: Figure 1-B**), these species are listed in the table below:

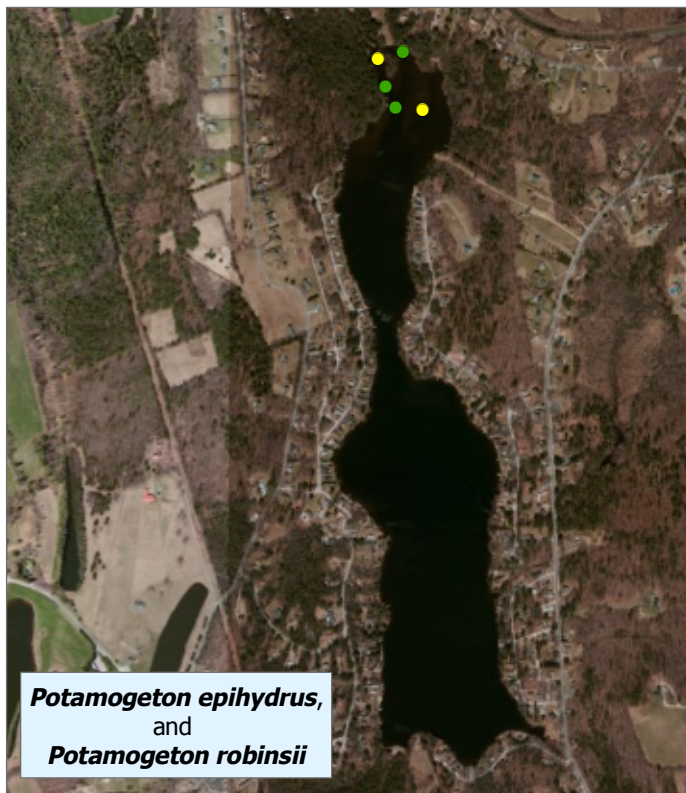
Figure 3-B: October 2014 Distribution of Remaining Aquatic Vegetation Species

Several additional indigenous aquatic vegetation species were noted throughout the littoral zone at varying densities at the time of the October survey (**Appendix: Figure 3-B**). The following table lists these species:
